Re: March 2016 Monthly Progress Report  
Administrative Settlement Agreement and Order on Consent for Removal Action  
U.S. EPA Region 10 Docket No. CERCLA 10-2009-0255  
Gasco Sediments Site within the Portland Harbor Superfund Site

Attachment A      Monthly Visual Monitoring Report for Pilot Cap Vicinity

## Visual Observations Log Form

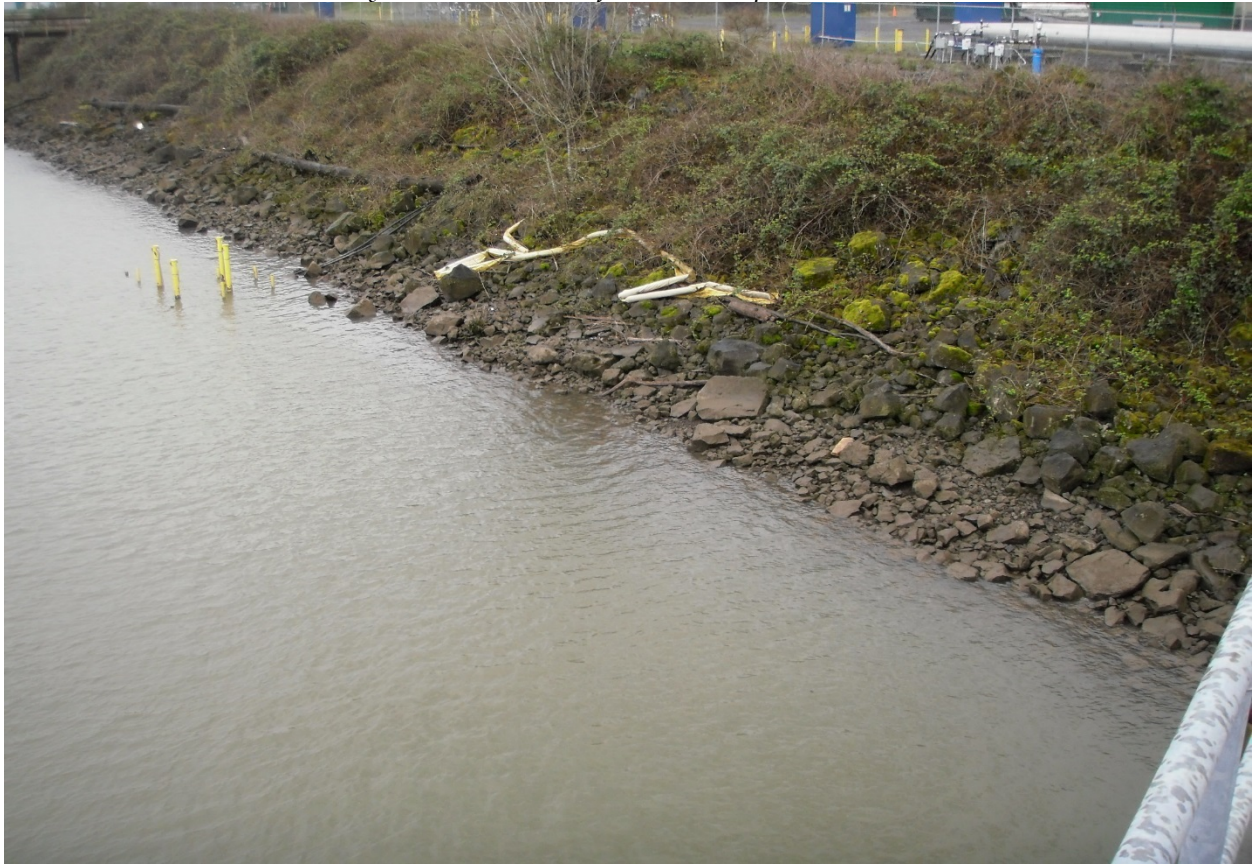
**Observations of Erosion/Deposition:** No erosion/deposition is evident along the shoreline. The shoreward extent of the cap was not visible due to high river water elevation and the extents of the organoclay mat material were also submerged. (Photo 1).

Photo 1 — *River level currently above the extent of sediment cap (3/21/16):*

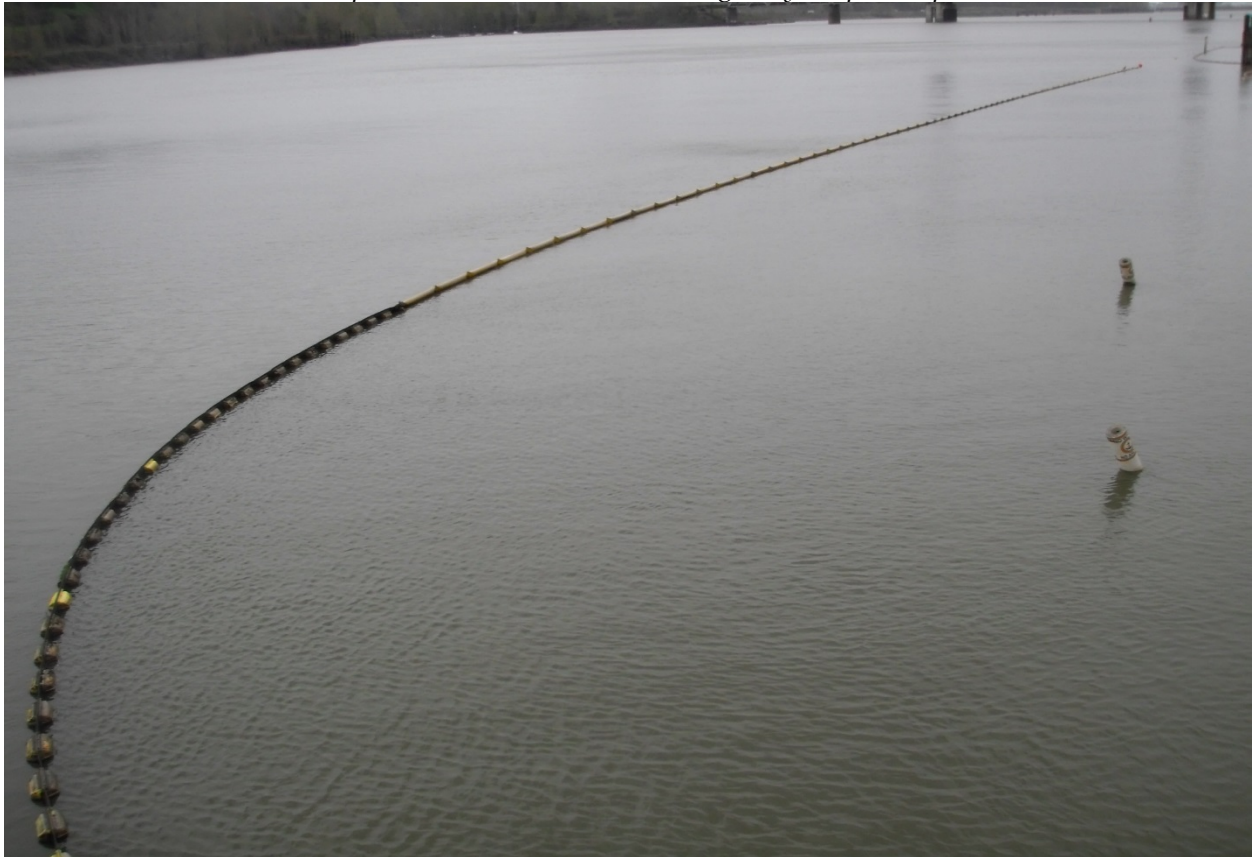
**Observations of Long-term Controls (i.e., oil booms, organo-clay mat, etc.)** During the observation, the FAMM containment boom was placed across the cap area, from the ship dock to an anchor point riverward of the upstream dolphin. Two buoys that identify the cap area to mariners are in place as installed. The position of the FAMM oil boom, warning buoys, and a general overview of the site shoreline is shown in Photo 2.

Photo 2 — *FAMM oil boom placement and mariner warning buoys at pilot cap area. (3/21/16):*

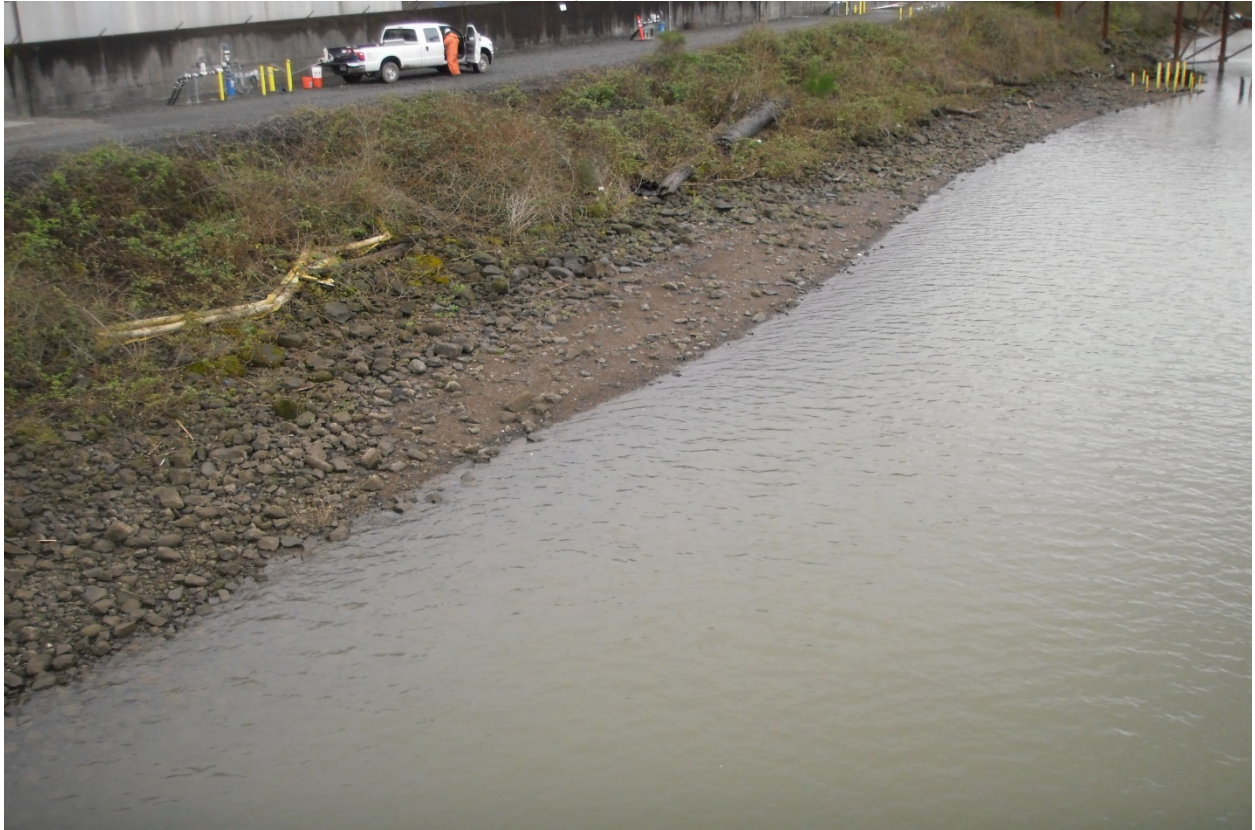
**Other Comments:** No sheen is evident in or around the cap area. Photo 3 shows the water surface and shoreline immediately downriver of the sediment cap.

Photo 3 — *Conditions immediately downriver of cap area (3/21/16):*
